# Express5800/R120h-1M (2nd-Gen), R120h-2M (2nd-Gen)

## ご使用時の注意事項

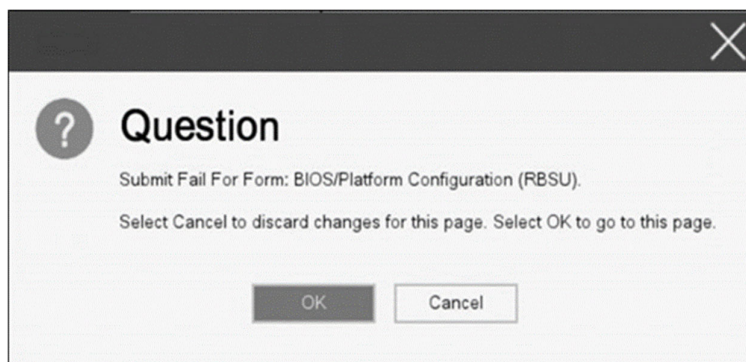
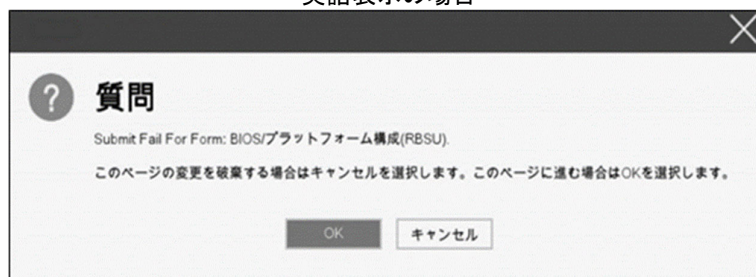
### ● Submit Fail For Form の Question(質問)ポップアップ表示についての注意事項

システムユーティリティにおいて設定の変更中に、次の Submit Fail For Form の Question(質問)ポップアップが表示された場合は、「キャンセル」を選択して変更を破棄してください。

さらに、サーバーの再起動を行ってシステムユーティリティに入り直してから設定の変更を再度行ってください。もし「OK」を押してそのまま設定変更を進めると、装置に記録されている Serial Number、Product ID などの設定情報が消失することがあります。

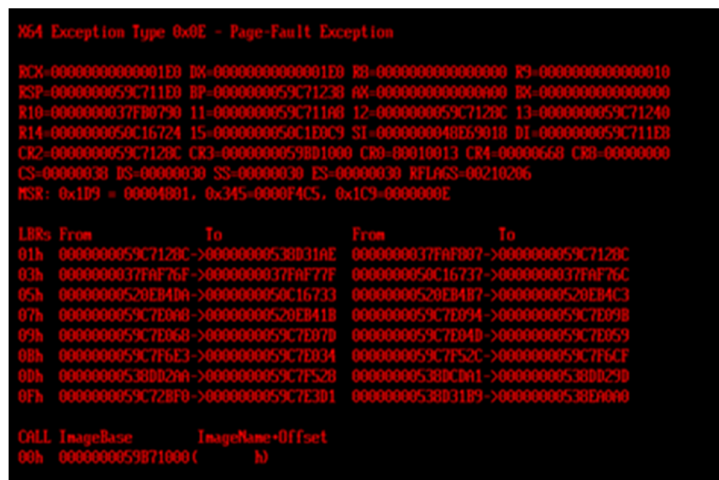
赤文字画面の例

装置の構成変更や設定変更などシステムの状態を変更した場合や、接続デバイスへのアクセスタイミングにより、OS 起動前にまれに赤文字画面 (RSOD) が表示され、本製品の操作ができなくなることがあります。構成変更や設定変更に伴う一過性の事象の場合があり電源をオフ、オンすることによって回復します。

赤文字画面 (RSOD) が表示された場合、装置の電源のオフ、オンをお願いします。  
問題が解決しないときは、ファーストコンタクトセンターにお問い合わせください。

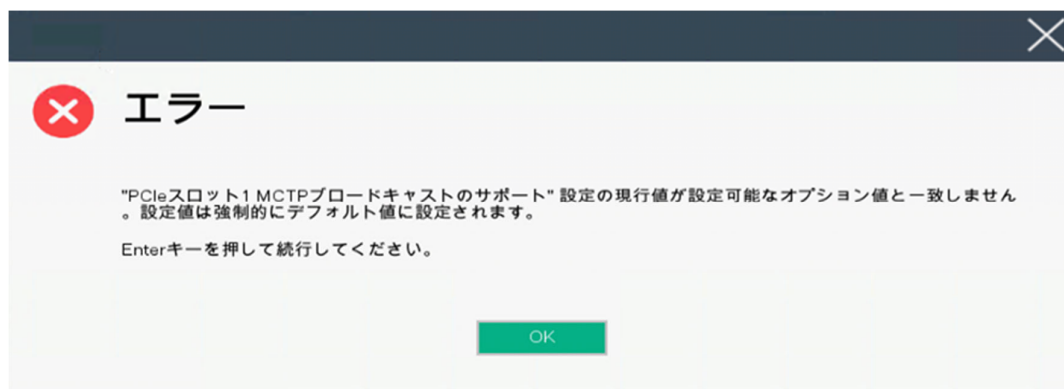
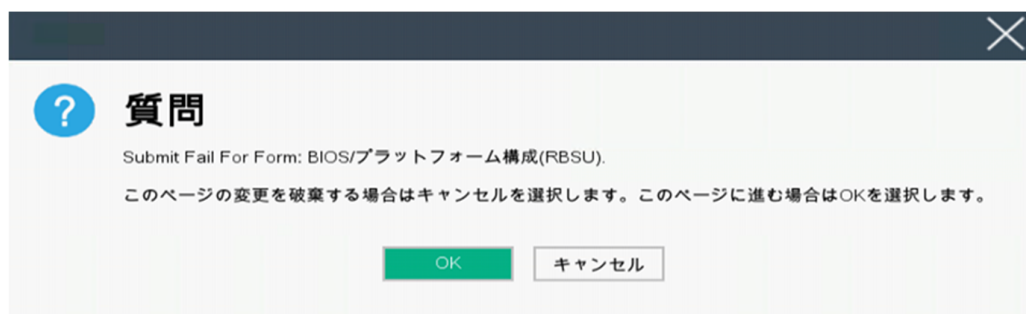
システム ROM バージョン 2.10 (05/21/2019) 以降の装置において、初めて PCIe MCTP Options メニュー(\*1) を選択した場合、装置のデフォルト設定を強制的に設定する旨のポップアップ(\*2)が、設定可能な PCIe Slot 数分表示されます。

なお、下記システム ROM バージョンの場合、設定保存時にポップアップ(\*3)が表示され設定は保存されません。保存されないことにより、本メニューを表示させるたびに PCIe Slot 数分のポップアップ(\*2)が表示されることになります。この場合、MCTP Broadcast は常に有効で動作します。

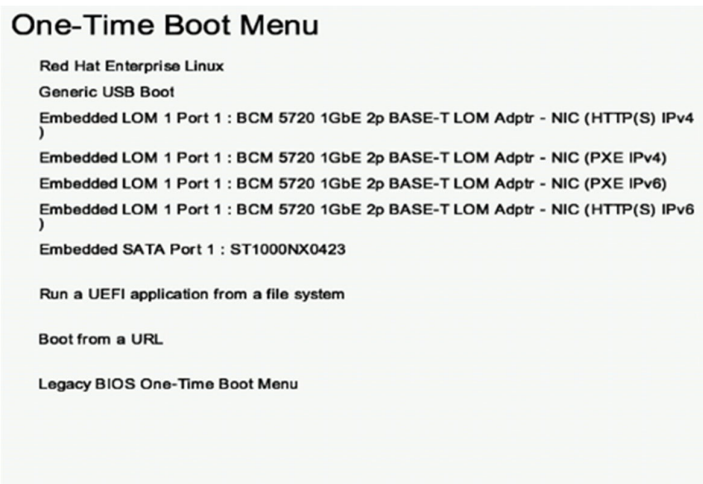
ワンタイムブートメニュー画面

OS がインストールされた HDD や SSD などのブートデバイスを選択した場合、RSOD (Red Screen Of Death) が発生することがあります。

ワンタイムブートメニューから起動する場合、OS ブートマネージャー（例：Red Hat Enterprise Linux）を選択してください。

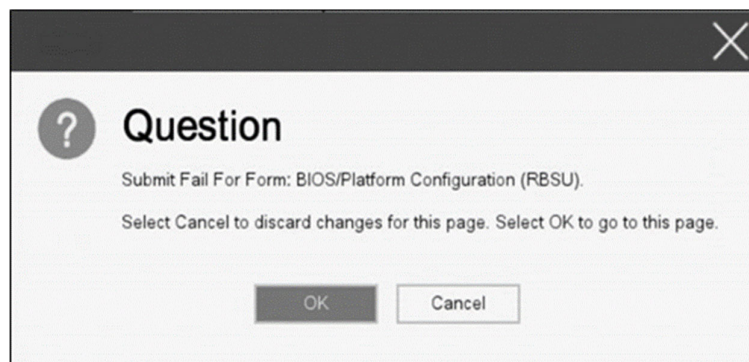
If you encounter the "Submit Fail For Form" Question pop-up while changing the configuration in the System Utilities, **discard the changes by pressing Cancel**. To apply the desired changes after that, reboot the server and re-enter the System Utilities. Selecting OK to continue the changes may cause some server settings such as Serial Number and Product ID to be lost.
