# Express5800/R120h-1M (3rd-Gen), R120h-2M (3rd-Gen)

## ご使用時の注意事項

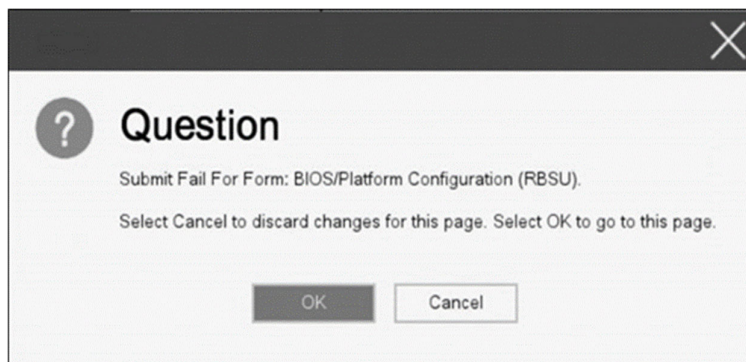
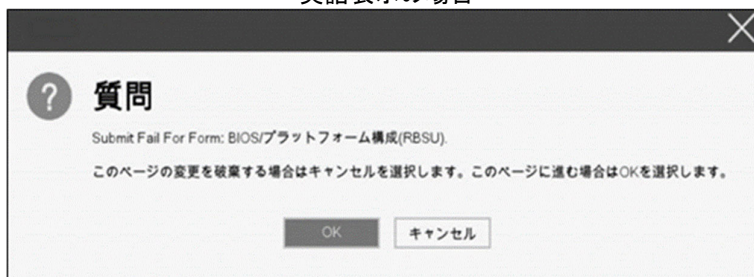
英語表示の場合

システムユーティリティにおいて設定の変更中に、次の Submit Fail For Form の Question(質問) ポップアップが表示された場合は、「キャンセル」を選択して変更を破棄してください。

さらに、サーバーの再起動を行ってシステムユーティリティに入り直してから設定の変更を再度行ってください。もし「OK」を押してそのまま設定変更を進めると、装置に記録されている Serial Number、Product ID などの設定情報が消失することがあります。

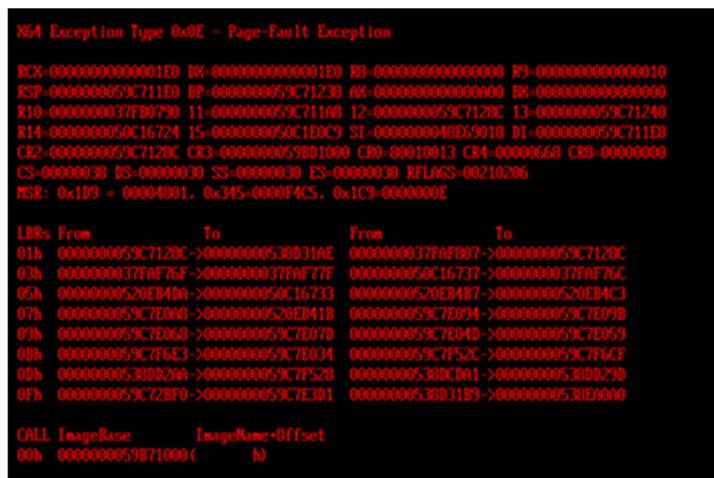
赤文字画面の例

装置の構成変更や設定変更などシステムの状態を変更した場合や、接続デバイスへのアクセスタイミングにより、OS 起動前にまれに赤文字画面 (RSOD) が表示され、本製品の操作ができなくなることがあります。構成変更や設定変更に伴う一過性の事象の場合があり電源をオフ、オンすることによって回復します。

赤文字画面 (RSOD) が表示された場合、装置の電源のオフ、オンをお願いします。  
問題が解決しないときは、ファーストコンタクトセンターにお問い合わせください。

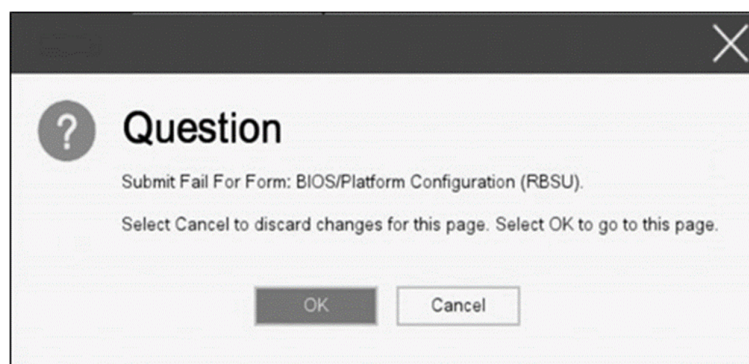
If you encounter the "Submit Fail For Form" Question pop-up while changing the configuration in the System Utilities, **discard the changes by pressing Cancel**. To apply the desired changes after that, reboot the server and re-enter the System Utilities. Selecting OK to continue the changes may cause some server settings such as Serial Number and Product ID to be lost.

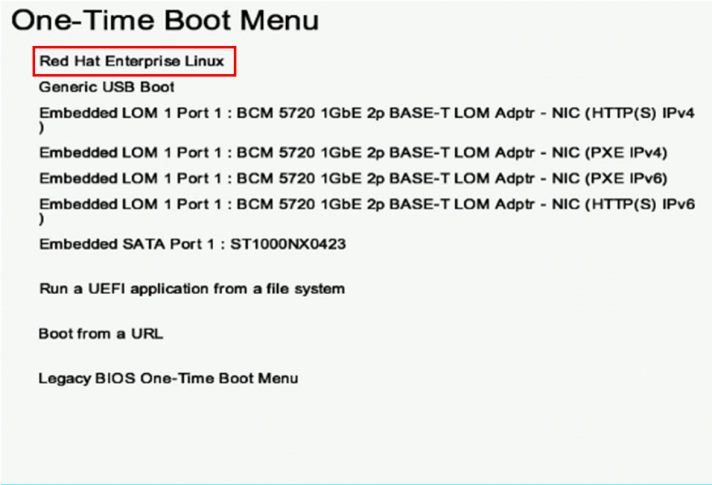
### One-Time Boot Menu

Selecting an OS boot device such as HDD/SSD on the "One-Time Boot Menu" may cause RSOD (Red Screen Of Death).
