# Express5800/R120h-1E, R120h-2E ご使用時の注意事項

- 1) はじめに
- 2) システムROMの機能に関する注意事項
- 3) iLO5の機能に関する注意事項
- 4) OSに関する注意事項
- 5) 全般の機能に関する注意事項
- A) ファームウェア変更に伴う変更点
- B) 誤記訂正

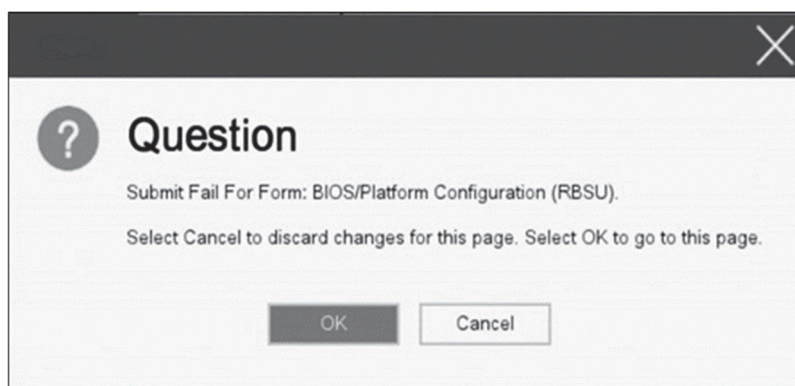
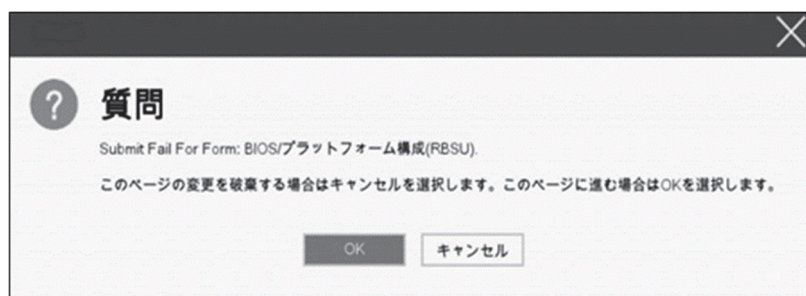
### ● Submit Fail For FormのQuestion(質問)ポップアップ表示についての注意事項

システムユーティリティにおいて設定の変更中に、次のSubmit Fail For FormのQuestion(質問)ポップアップが表示された場合は、「キャンセル」を選択して変更を破棄してください。

さらに、サーバーの再起動を行ってシステムユーティリティに入り直してから設定の変更を再度行ってください。もし「OK」を押してそのまま設定変更を進めると、装置に記録されているSerial Number、Product ID などの設定情報が消失することがあります。

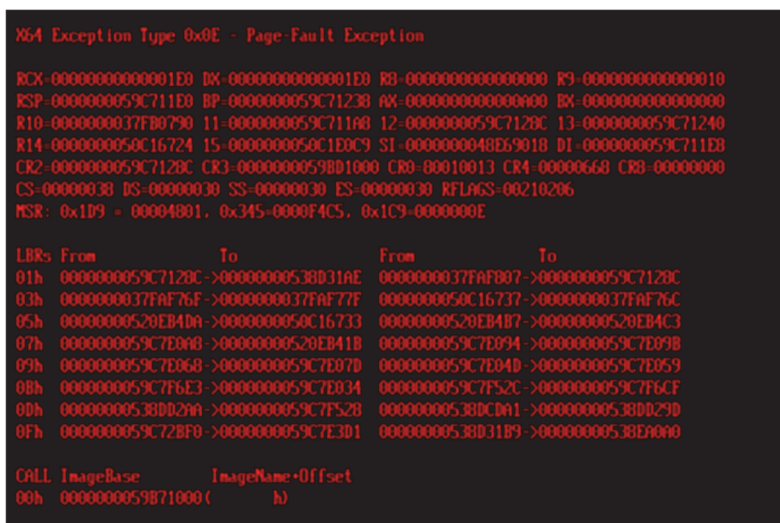
赤文字画面の例

## ● 赤文字画面 (RSoD : Red Screen of Death) が表示された場合の対処について

装置の構成変更や設定変更などシステムの状態を変更した場合や、接続デバイスへのアクセスタイミングにより、OS起動前にまれに赤文字画面 (RSoD) が表示され、本製品の操作ができなくなることがあります。構成変更や設定変更に伴う一過性の事象の場合があり電源オフ、オンによって回復します。

赤文字画面 (RSoD) が表示された場合、装置の電源オフ、オンをお願いします。

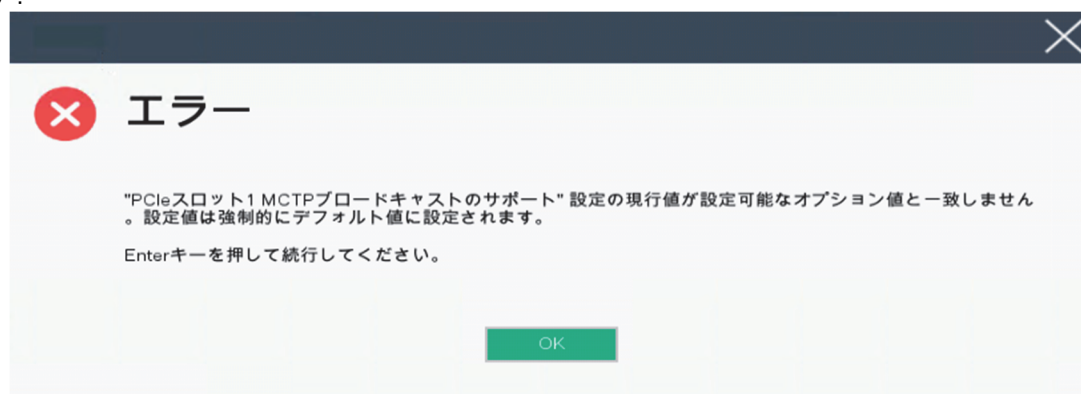
(\*2) :

システムROMバージョン2.10以降の装置において、初めてPCIe MCTP Optionsメニュー(\*1)を選択した場合、装置のデフォルト設定を強制的に設定する旨のポップアップ(\*2)が、設定可能なPCIe Slot数分表示されます。設定を一度保存すると、次回以降ポップアップ表示はされません。

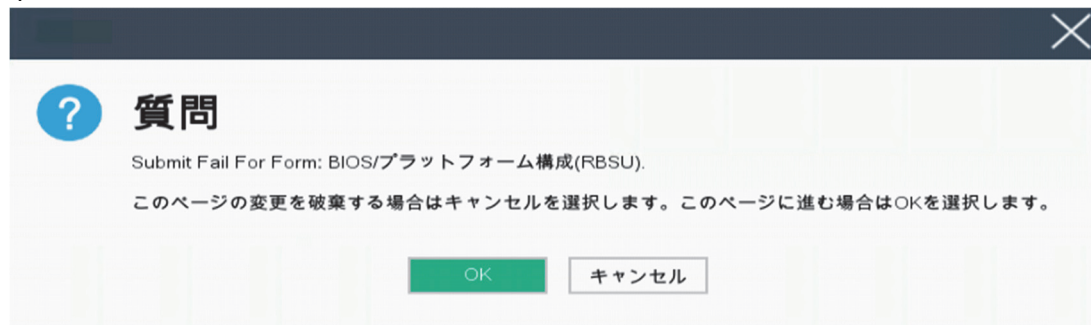
(\*3) :

なお、下記システムROMバージョンの場合、設定保存時にポップアップ(\*3)が表示され設定は保存されません。保存されないことにより、本メニューを表示させるたびにPCIe Slot数分のポップアップ(\*2)が表示されることになります。この場合、MCTP Broadcastは常に有効で動作します。

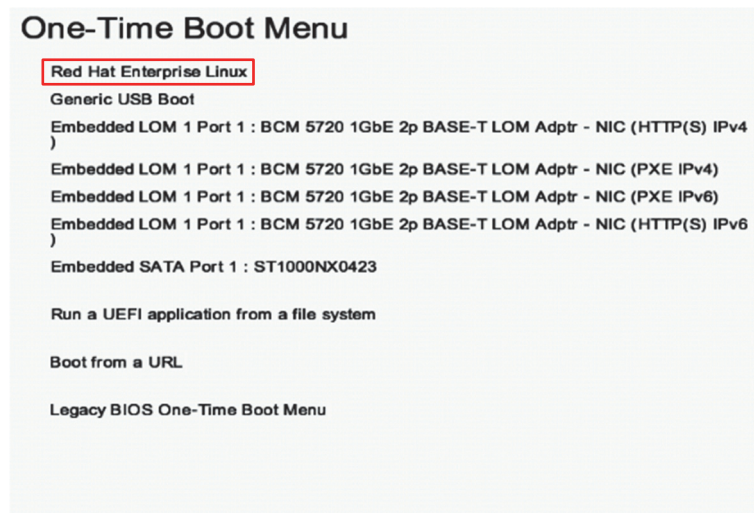
ワンタイムブートメニュー画面

OSがインストールされたHDDやSSDなどのブートデバイスを選択した場合、Red Screen of Death (RSoD) が発生することがあります。

ワンタイムブートメニューから起動する場合、OSブートマネージャー (例: Red Hat Enterprise Linux) を選択してください。

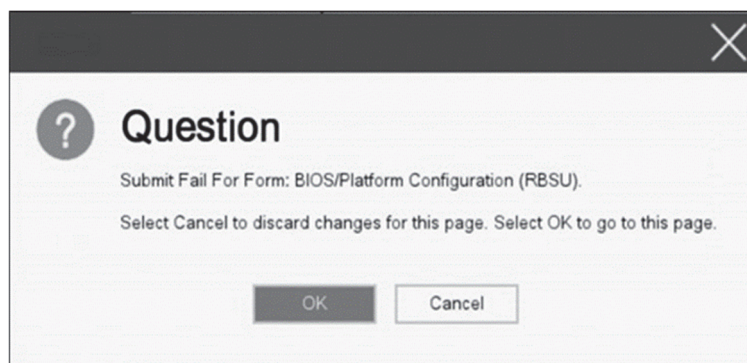
### • Caution for the "Submit Fail For Form" Question pop-up

If you encounter the "Submit Fail For Form" Question pop-up while changing the configuration in the System Utilities, **discard the changes by pressing Cancel**. To apply the desired changes after that, reboot the server and re-enter the System Utilities. Selecting OK to continue the changes may cause some server settings such as Serial Number and Product ID to be lost.

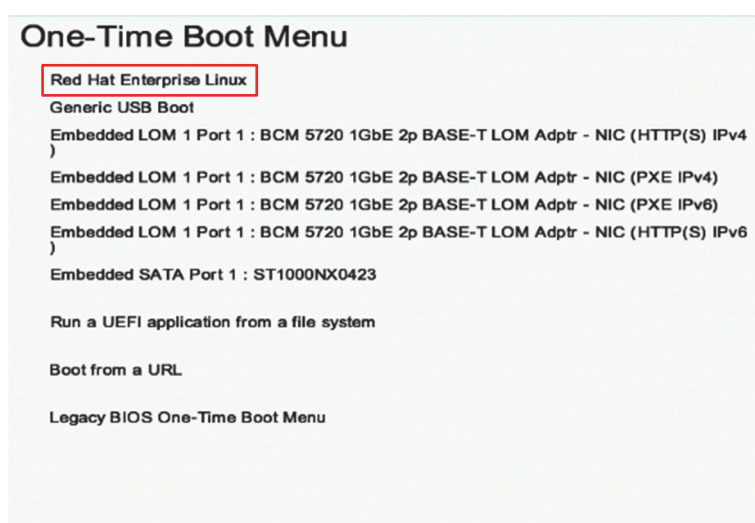
One-Time Boot Screen

Selecting an OS boot device such as HDD/SSD on the "One-Time Boot Menu" may cause RSoD (Red Screen of Death).

Select "OS Boot Manager" when booting OS from "One-Time Boot Menu".
