# Express5800/R110j-1 ご使用時の注意事項

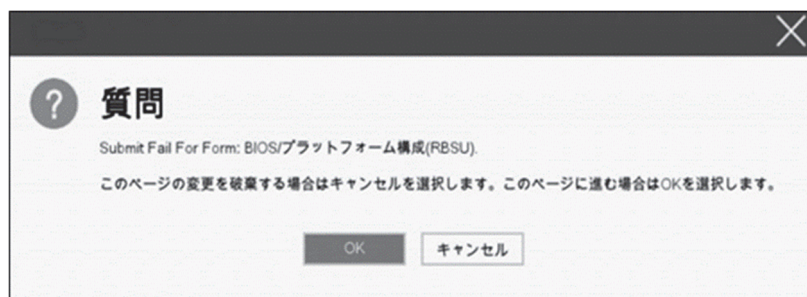
### ● Submit Fail For FormのQuestion(質問)ポップアップ表示についての注意事項

システムユーティリティにおいて設定の変更中に、次のSubmit Fail For FormのQuestion(質問)ポップアップが表示された場合は、「キャンセル」を選択して変更を破棄してください。

さらに、サーバーの再起動を行ってシステムユーティリティに入り直してから設定の変更を再度行ってください。もし「OK」を押してそのまま設定変更を進めると、装置に記録されているSerial Number、Product IDなどの設定情報が消失することがあります。

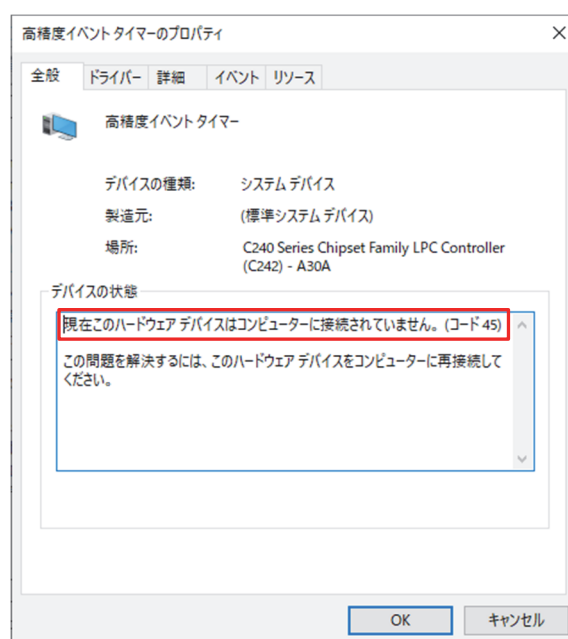
高精度イベントタイマーのプロパティ画面

システム ROM バージョン 2.52 未満の場合、Windows (R) デバイスマネージャーに高精度イベントタイマーが表示されず、使用できません。

本問題が発生した場合、高精度イベントタイマーのプロパティに以下のメッセージが表示されます。

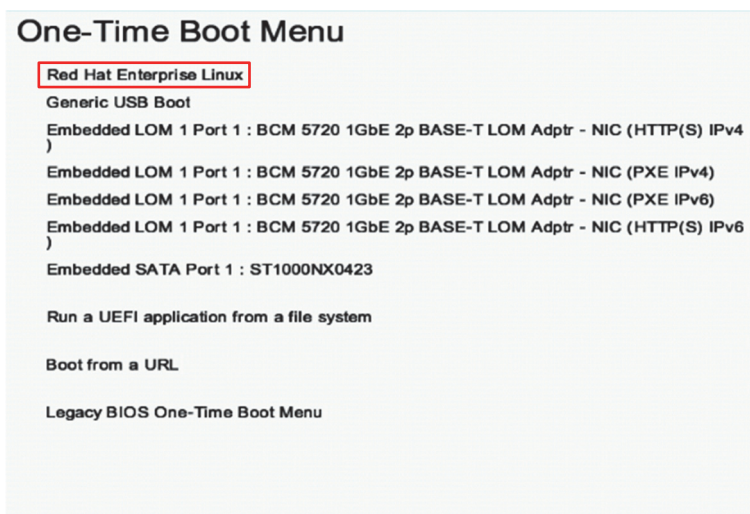
ワンタイムブートメニュー画面

ワンタイムブートメニューから起動する場合、OSブートマネージャー(例: Red Hat Enterprise Linux)を選択してください。

OSがインストールされたHDDやSSDなどのブートデバイスを選択した場合、Red Screen of Death (RSoD)が発生することがあります。

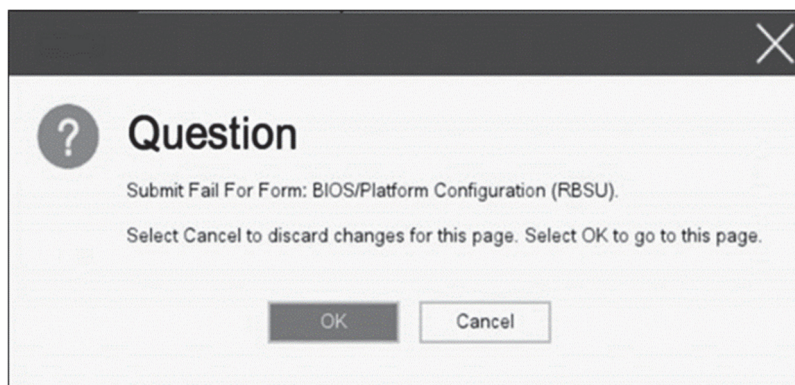
### ● Caution for the "Submit Fail For Form" Question pop-up

If you encounter the "Submit Fail For Form" Question pop-up while changing the configuration in the System Utilities, **discard the changes by pressing Cancel**. To apply the desired changes after that, reboot the server and re-enter the System Utilities. Selecting OK to continue the changes may cause some server settings such as Serial Number and Product ID to be lost.

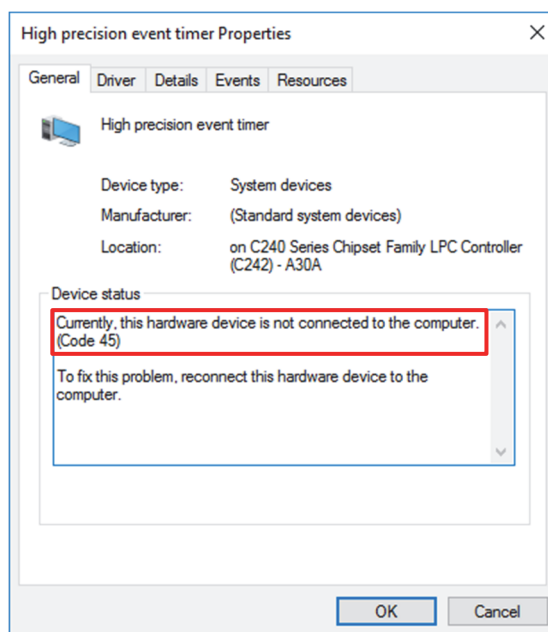
When System ROM version is earlier than 2.52, the High Precision Event Timer (HPET) is not displayed in the Windows(R) Device Manager and cannot be used.

When this issue occurs, the following message will be displayed in the properties of the High Precision Event Timer.

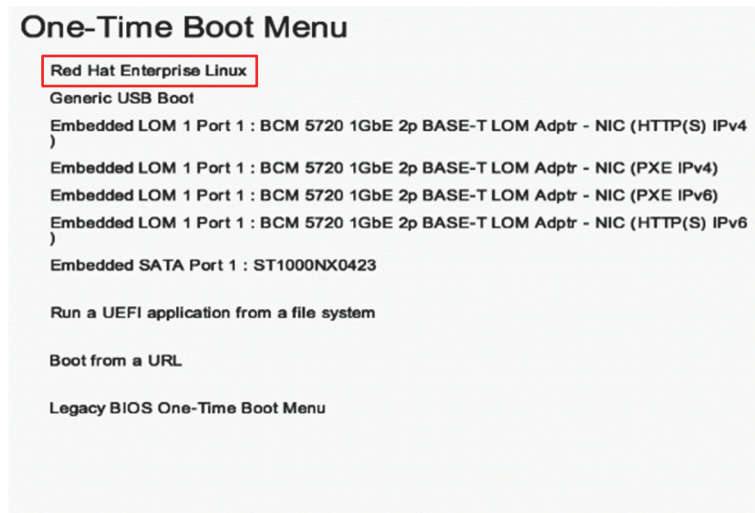
One-Time Boot Screen

Select "OS Boot Manager" when booting OS from "One-Time Boot Menu".

Selecting an OS boot device such as HDD/SSD on the "One-Time Boot Menu" may cause RSoD (Red Screen of Death).
