# Express5800/R120i-1M, R120i-2M ご使用時の注意事項

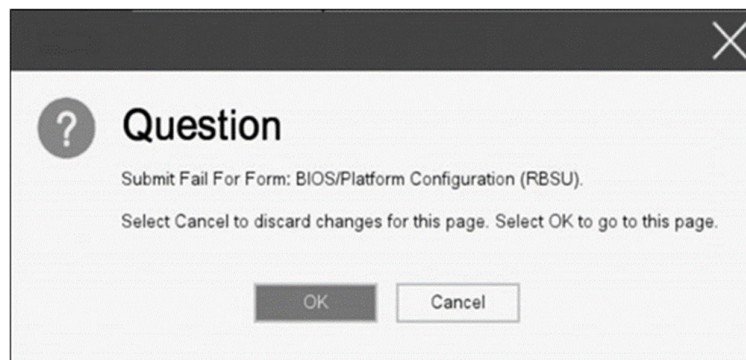
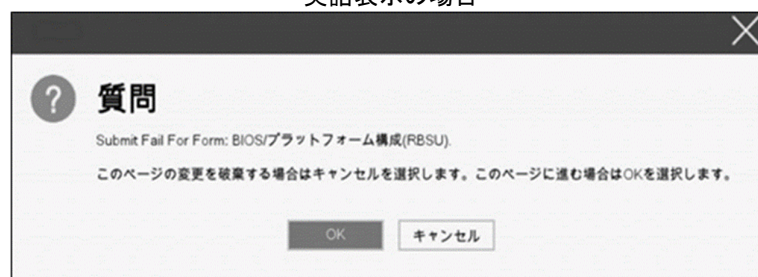
システムユーティリティにおいて設定の変更中に、次の Submit Fail For Form の Question(質問)ポップアップが表示された場合は、「キャンセル」を選択して変更を破棄してください。

さらに、サーバーの再起動を行ってシステムユーティリティに入り直してから設定の変更を再度行ってください。もし「OK」を押してそのまま設定変更を進めると、装置に記録されている Serial Number、Product ID などの設定情報が消失することがあります。

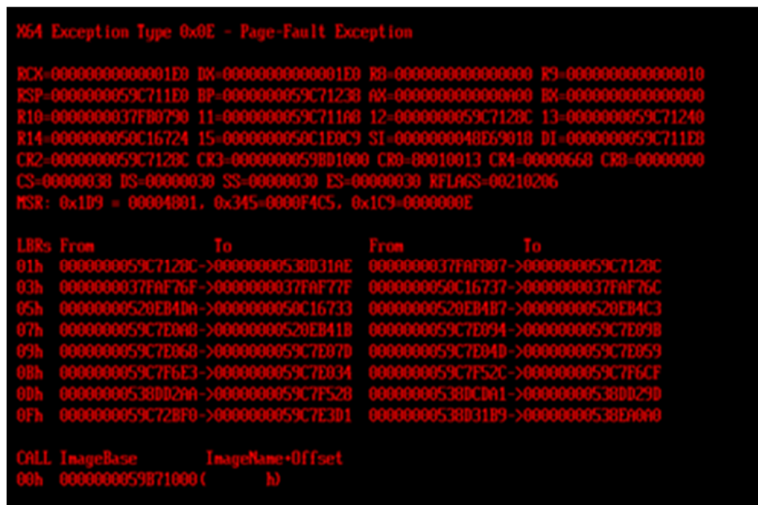
赤文字画面の例

装置の構成変更や設定変更などシステムの状態を変更した場合や、接続デバイスへのアクセスタイミングにより、OS 起動前に稀に赤文字画面(RSOD)が表示され、本製品の操作ができなくなることがあります。構成変更や設定変更に伴う一過性の事象の場合があり電源をオフ、オンすることによって回復します。

赤文字画面(RSOD)が表示された場合、装置の電源のオフ、オンをお願いします。  
問題が解決しないときは、ファーストコンタクトセンターにお問い合わせください。

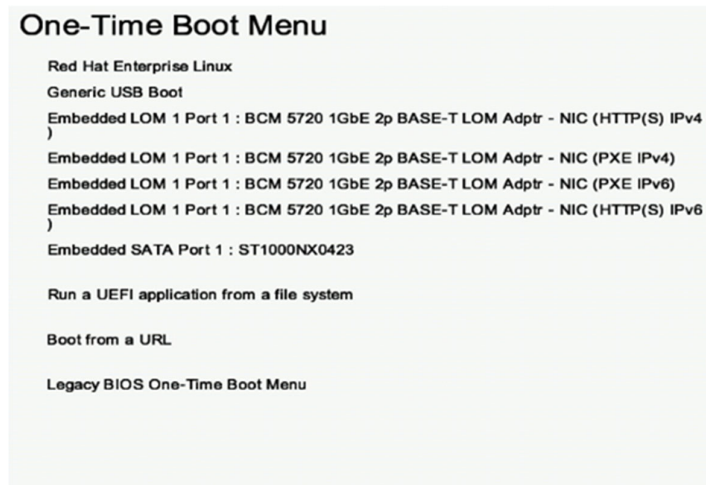
ワンタイムブートメニュー画面

OS がインストールされた HDD や SSD などのブートデバイスを選択した場合、RSOD(Red Screen Of Death)が発生することがあります。

ワンタイムブートメニューから起動する場合、OS ブートマネージャー(例: Red Hat Enterprise Linux)を選択してください。

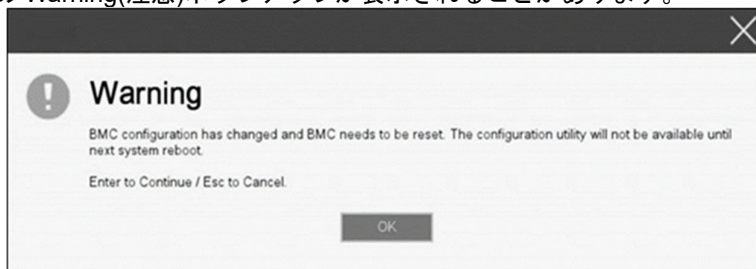
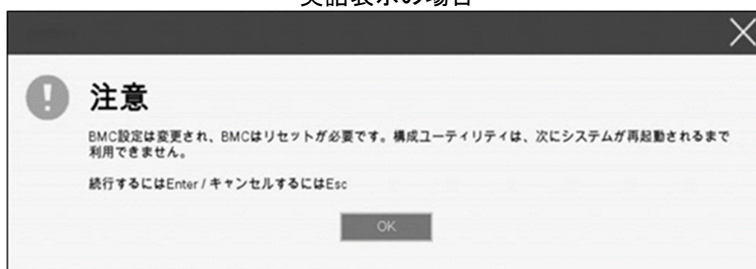
- (1) システムユーティリティの「BMC Configuration Utility」において設定の変更を行うと、iLO の再起動を行うために、次の Warning(注意)ポップアップが表示されることがあります。

- (2) 「OK」を押して進めます。

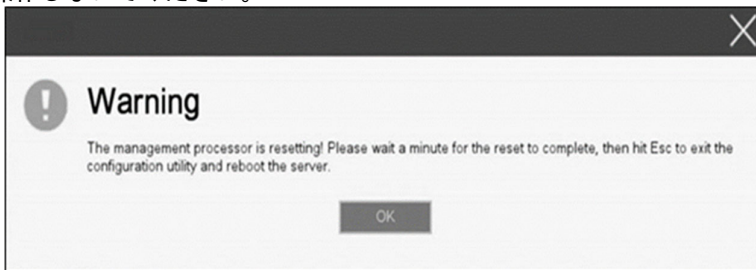
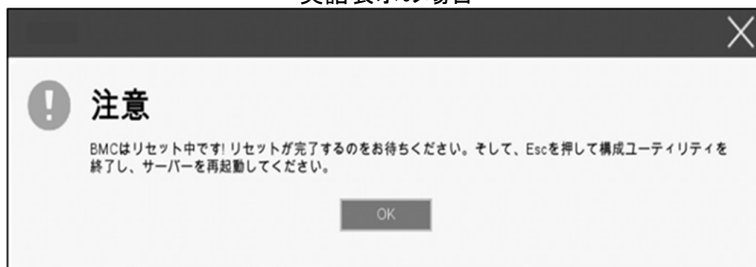
- (3) 次の Warning(注意)ポップアップが表示されます。

この Warning(注意)ポップアップが表示されている状態にて、必ず 1 分以上お待ちください。  
その間、何も操作しないでください。

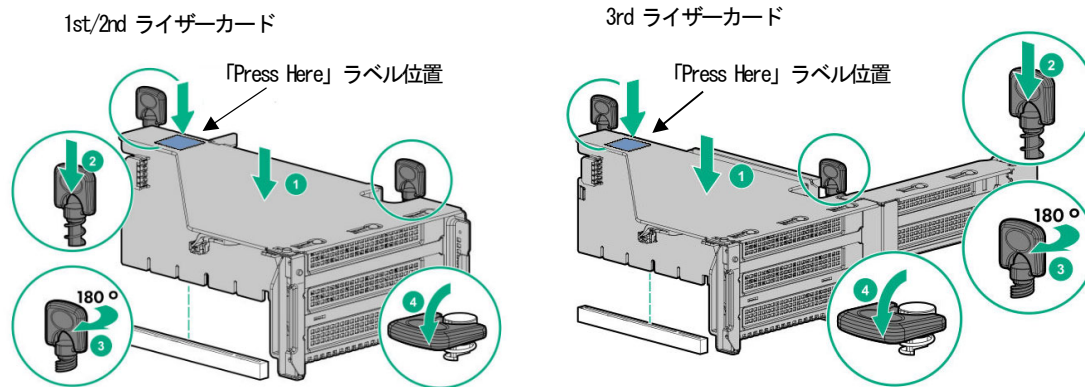
コネクタ適合不良が起こると、装置前面のStatus LEDが赤点滅します。

赤点滅した場合には本装置を電源OFFしてACケーブルを抜き、ライザーケース上面の「Press Here」ラベル部分を押ししてください。

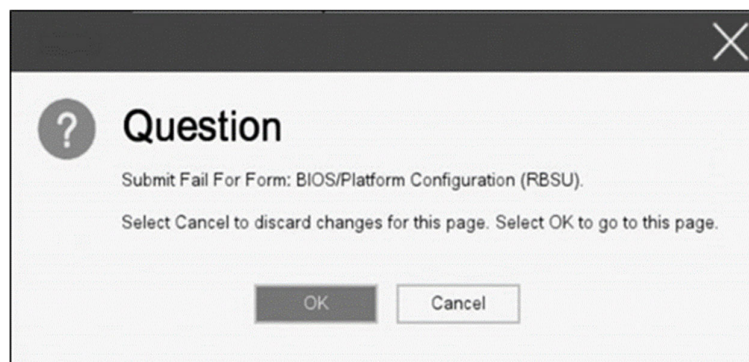
If you encounter the "Submit Fail For Form" Question pop-up while changing the configuration in the System Utilities, **discard the changes by pressing Cancel**. To apply the desired changes after that, reboot the server and re-enter the System Utilities. Selecting OK to continue the changes may cause some server settings such as Serial Number and Product ID to be lost.

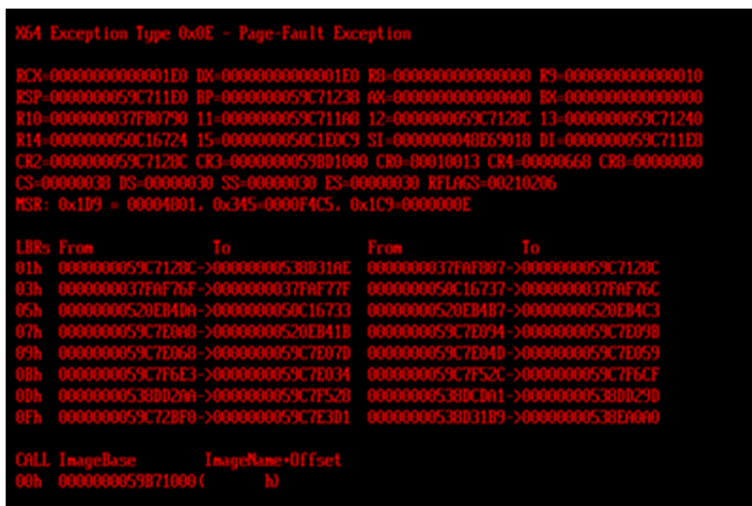
If you have changed the server configuration/settings or the system status, a Red Screen of Death (RSOD) screen appears in rare cases before starting up the OS. This may cause the server to become uncontrollable. However, the server may recover from the RSOD by turning off and then on the power again.

To recover from this condition, power off and then on the server again.  
If the problem persists, contact your sales representative for maintenance.

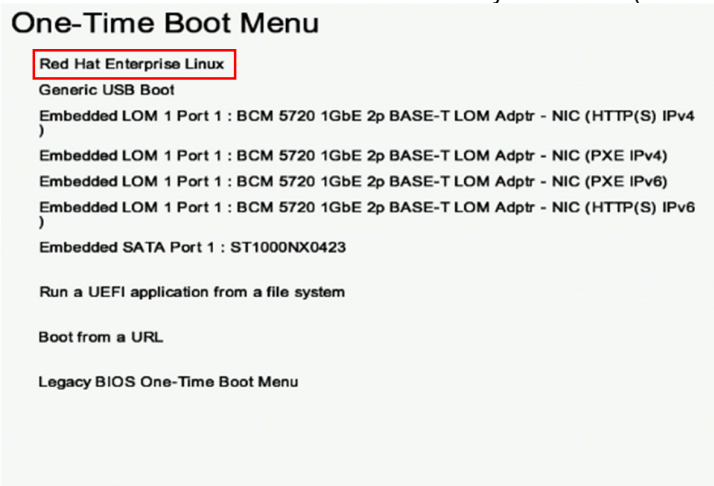
### One-Time Boot Menu

Selecting an OS boot device such as HDD/SSD on the "One-Time Boot Menu" may cause RSOD (Red Screen Of Death).

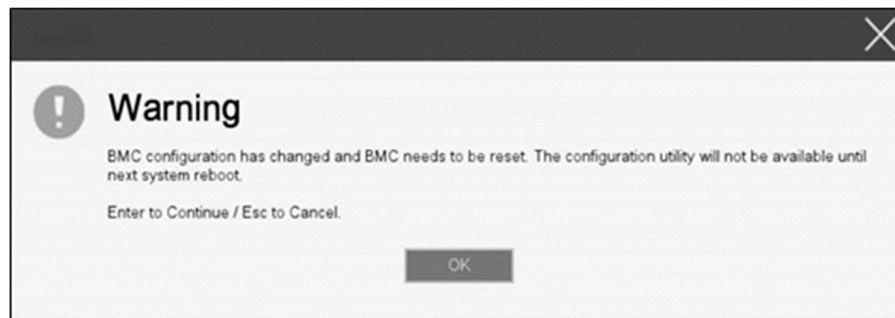
- (1) In the System Utilities, changing the settings of BMC Configuration Utility may display the following pop-up before rebooting the iLO:

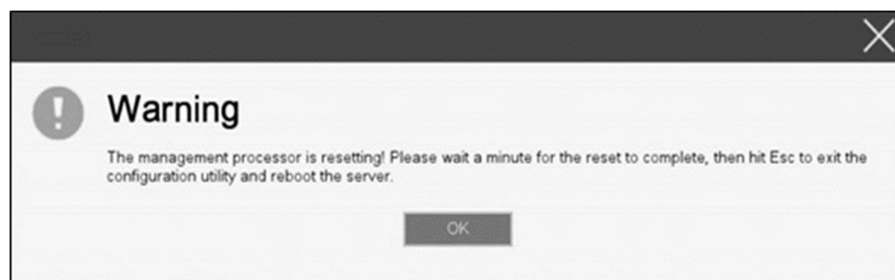
- (3) The iLO will start to reboot and then the following pop-up appears:

- (4) Leave this pop-up at least for one minute.

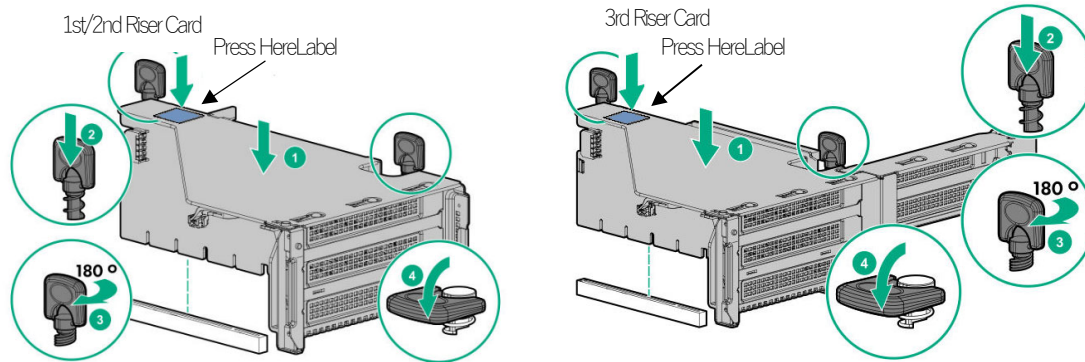
If the connector mismatch occurs, the Status LED on the front of the unit will blink red.

If the Status LED is blinking red, turn off the server, unplug the AC cable, and press the "Press Here" label on the top of the riser cage.
