# Express5800/R120h-1E, R120h-2E ご使用時の注意事項

- 1) はじめに
- 2) システムROMの機能に関する注意事項
- 3) iLO5の機能に関する注意事項
- 4) OSに関する注意事項
- 5) 全般の機能に関する注意事項
- A) ファームウェア変更に伴う変更点
- B) 誤記訂正

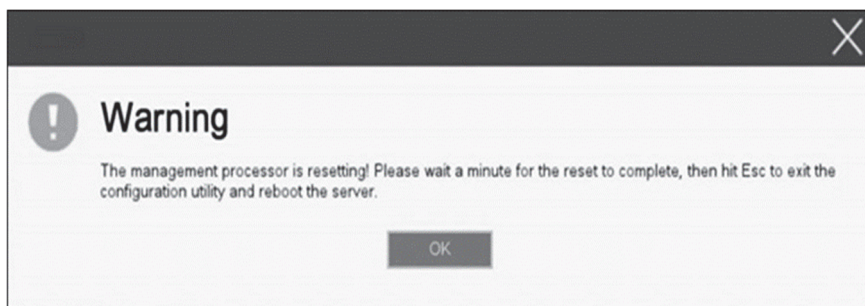
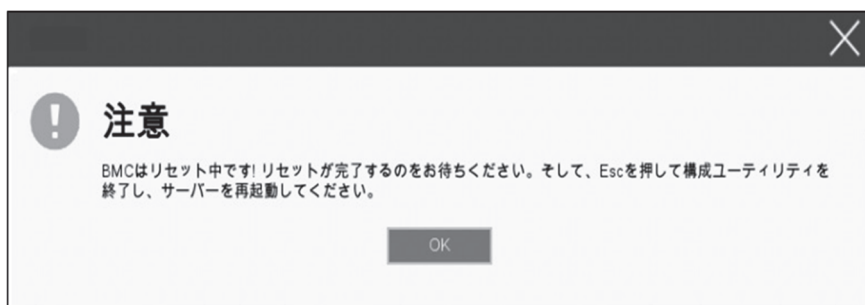
- ③ 次のWarning (注意) ポップアップが表示されます。  
このWarning (注意) ポップアップが表示されている状態にて、**必ず1分以上**お待ちください。  
その間、何も操作しないでください。

- ④ 1分以上経過後、装置前面のステータスランプが緑色で点灯していることを確認してください。
  - ・ iLOが再起動中 : ステータスランプが緑色で点滅（毎秒1回）
  - ・ iLOの再起動が完了し正常動作 : ステータスランプが緑色で点灯
- ⑤ ④において、iLOの再起動の完了を確認後、〈ESC〉キーを複数回押して、システムユーティリティの画面に戻ります。
- ⑥ システムユーティリティの「Reboot the System」を選択して対象サーバーを再起動します。

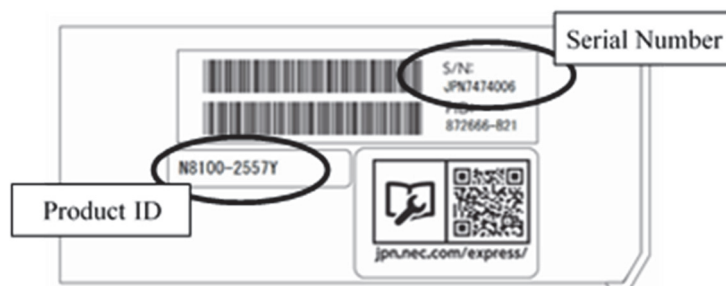
- ⑬ 装置のスライドタグに記載されているSerial NumberとProduct IDをシステムユーティリティの「System Configuration > BIOS/Platform Configuration (RBSU) > Advanced Options > Advanced Service Options」メニューより、設定します。

**【重要】Product IDとは、『N8100-2602Y』のような型番のことです。**

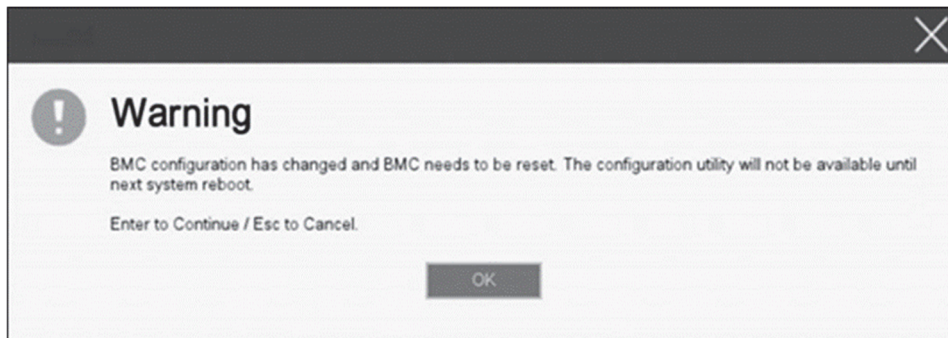
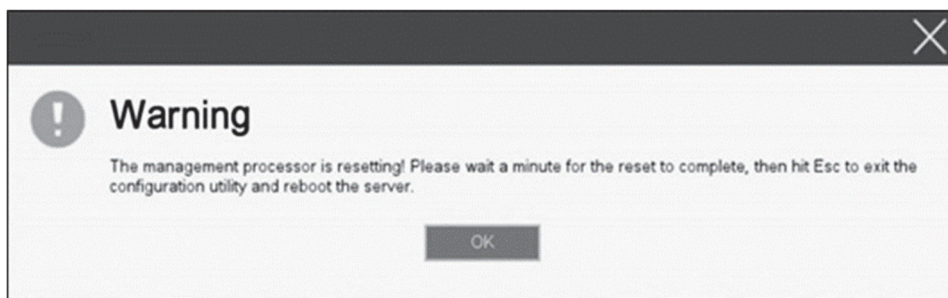
- (1) In the System Utilities, changing the settings of BMC Configuration Utility may display the following pop-up before rebooting the iLO:

- (2) Press OK to proceed.
- (3) The iLO will start to reboot and then the following pop-up appears:

- (4) Leave this pop-up at least for one minute.
- (5) Confirm if the iLO reboot is completed.  
※the iLO is restarting : the Status LED flashes in green (once per second) the iLO is operating normally through the restart completion : the Status LED lights in green.
- (6) If the confirmation succeeds, press OK to proceed.
- (7) Press the ESC key several times to return to the top screen of the System Utilities.
- (8) From the top screen, select Reboot the System to reboot the server.

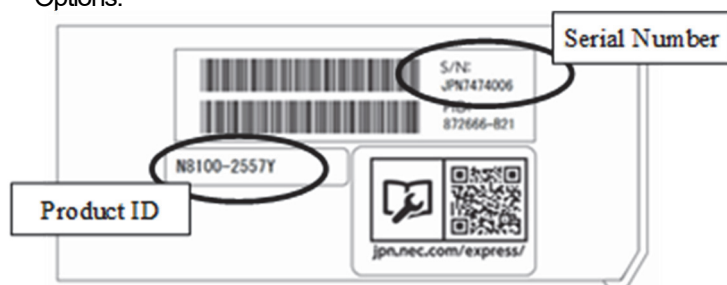
- (8) If the values are unexpected or lost, select the menu of the System Utilities: System Configuration > BIOS/Platform Configuration (RBSU) > System Default Options.
- (9) Select the Restore Default Manufacturing Settings option.
- (10) Select this option: Yes, restore the default settings.
- (11) The server restarts automatically and the POST screen appears.
- (12) Press the F9 key to enter the System Utilities.
- (13) Set the proper Serial Number and Product ID (indicated on the pull-out tab of the server) via the menu of the System Utilities: System Configuration > BIOS/Platform Configuration (RBSU) > Advanced Options > Advanced Service Options.

【Important】 Product ID is the model number like "N8100-2602F". Product ID is not PID.
